Global Auto Spares, Gold Coast Queensland

Renovating a commercial warehouse/distribution facility

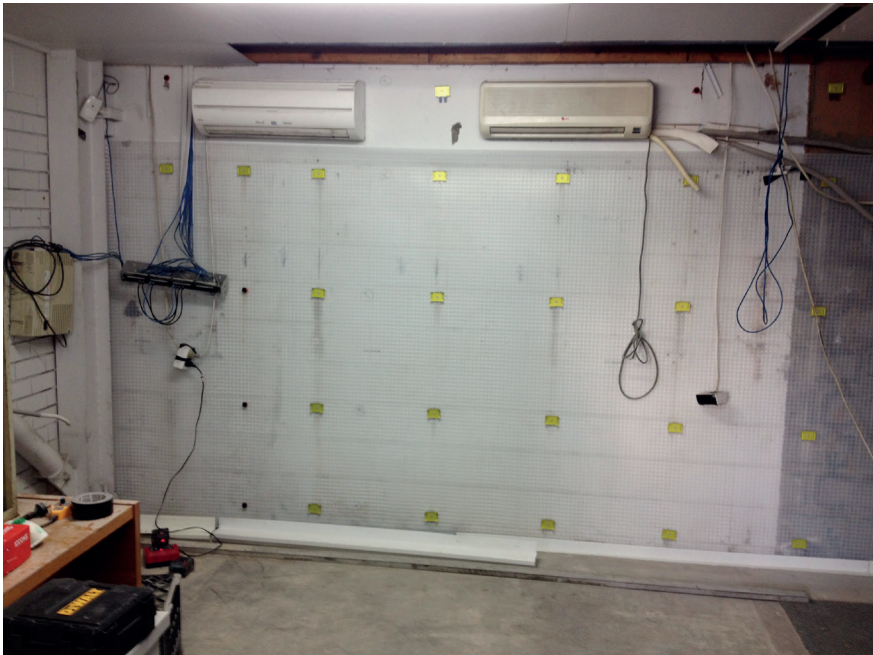
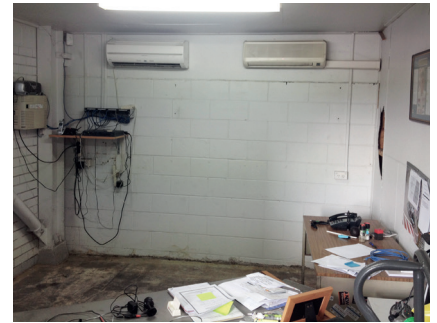
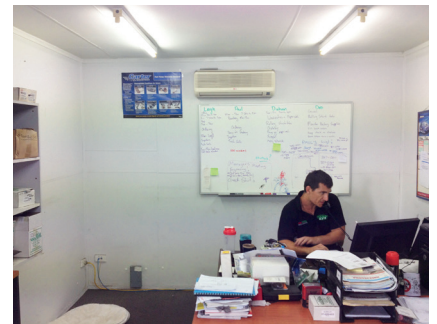
The wall had extensive damage to the existing paint coatings, and in wet periods would allow a substantial water penetration. The water had repeatedly damaged carpets in the office, and has caused rusting to many of the metal shelving in the warehouse area. This ponding water was a Health and Safety slip hazard to the employees.

Prior to finding Wetlock, the client had contacted several waterproofing contractors, none of whom could provide a solution or quote for the work, let alone provide a warranty. Newton System 500 was selected as it provided guaranteed results, did not require removal of existing paint coatings reducing downtime to the business, and the system allowed for the installation of a battened wall lining system that would protect the membrane from inadvertent damage in the warehouse area. Slab thicknesses allowed for the Newton Basedrain to be fully rebated into the floor with a 30mm cement-grout topping over it which allowed storage shelves to be placed hard up against the new walls and on top of the Basedrain without damage.

Works were taken from start to finish by Wetlock, including demolition, Newton 500 installation, and reinstatement of all wall linings and detailing.
