Varsity Lakes, Gold Coast, Queensland

Renovating an aged care facility

CASE STUDY - REMEDIAL WATERPROOFING

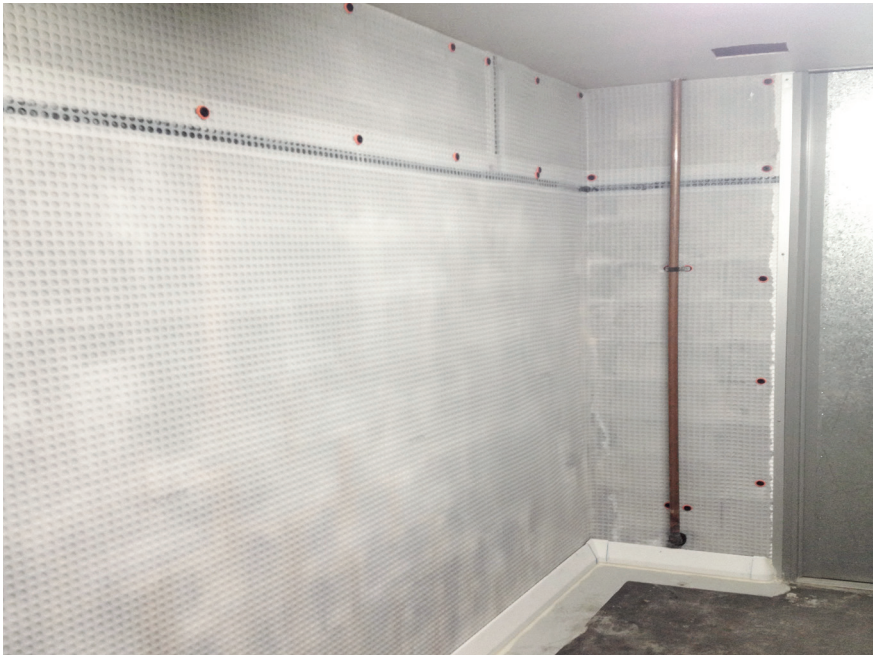
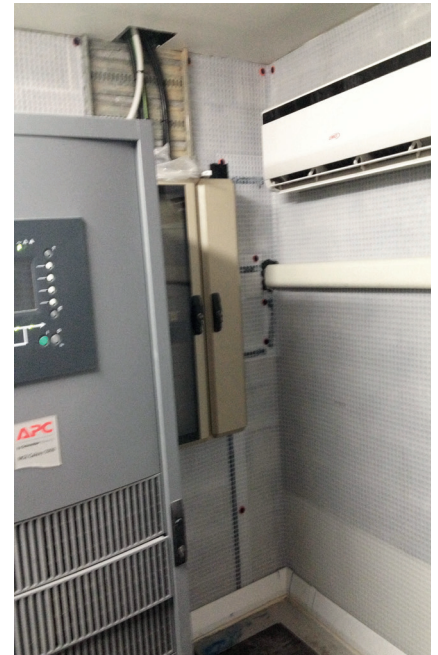
This four-level aged care facility had a partial basement and suffered extensive water ingress issues throughout, in particular the room which housed the battery backup system. This system needed to remain fully operational throughout the works

Data File	Project Description	Methodology & Result
<p>Overview</p> <p>Property Type Commercial</p> <p>Project Type Remedial</p> <p>Products used</p> <ul style="list-style-type: none"> Newton System 500 Newton Baseboard <p>Key project factors</p> <ul style="list-style-type: none"> External access not possible Backup battery system needed to be fully operational throughout the works Partially below ground <p>Contractor</p> <ul style="list-style-type: none"> Wetlock Waterproofing <p>Distributor</p> <ul style="list-style-type: none"> Bayset Pty Ltd 	<p>The premium quality aged care facility spreads across 4 levels accommodates over 110 tenants.</p> <p>The partial basement/ground level houses all reception, office, car parking, laundry, kitchen, electrical and water storage services. Whilst the building is quite new, it has had many water ingress issues throughout, but in particular was the ingress into the room which houses the UPS (backup battery system) which keeps all critical medical equipment operational during power failures.</p> <p>Water was leaking in through a failed waterproofing membrane on the external subgrade wall, and in heavy rain periods could cause up to 20mm of ponding water on the floor where many of the high voltage power cables were located introducing a serious electrocution and system failure risk.</p>	<p>Newton 500 was specified because there was no access to the external walls to re-waterproof, and the client wished to have the most reliable long-term solution available. Health and Safety protocols and also required the UPS system to remain fully operational throughout works. The works could not introduce any additional risks to the equipment (i.e. dust or moisture) that would occur with the installation of an alternate liquid applied or render coating.</p> <p>Newton 503 membrane was fixed to the walls, and Newton Baseboard to the wall/floor perimeters. Baseboard was specified as its installation did not require any dusty surface preparation works, and the room could be reinstated to full use quickly.</p> <p>The system did not have any wall sheeting installed over as the room is for specific use only and was not required, allowing for very easy visual inspection.</p>
