Broadbeach, Gold Coast

Waterproofing a new basement storage area

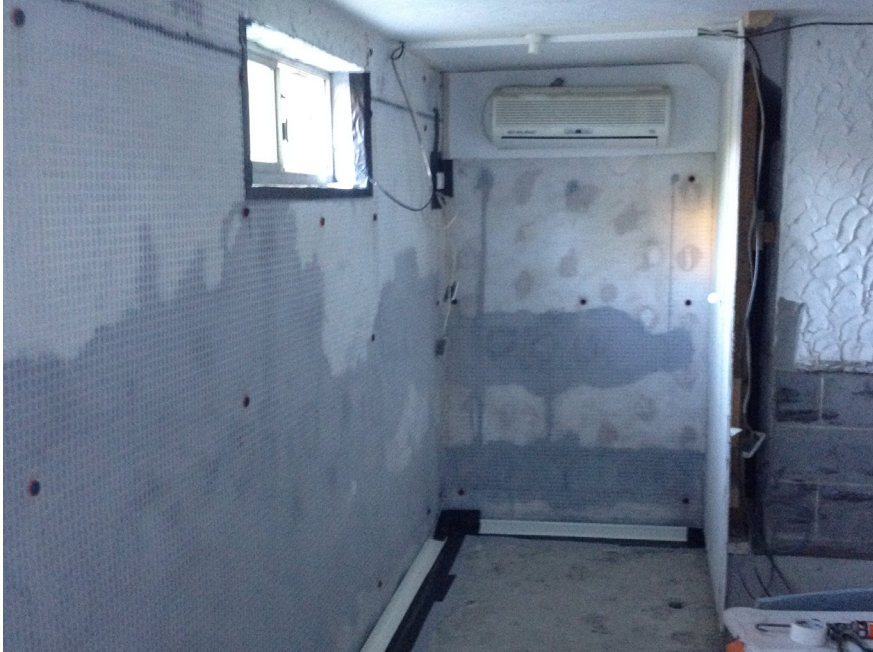
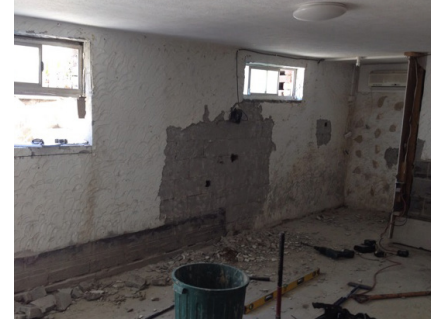
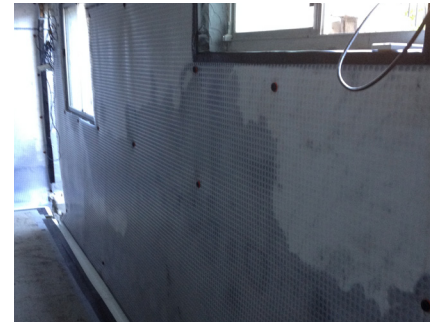
The property is the last one in a line of units, all built over a basement car-parking area. The owners wanted to convert the basement storage area into a 'granny flat' and Newton System 500 was installed internally to treat water ingress.

The builder coordinated the cutting and forming of the Newton Basedrain channels as directed by Wetlock Waterproofing, and Wetlock undertook all Newton System 500 installation works including applying Newton cavity drain membranes to all internal walls.

It was found that the existing blockwork walls were not corefilled with concrete, but had in fact been filled with sand and soil that had collapsed into the cavities over the last 35 or so years. Wetlock removed as much of this as possible, and then used their concrete grout pump to fill the bricks with a flow-fill cementitious grout.
